Indoor Pool Refurb Picture Journal!

Written by Arthur Knight Hammer

We have just completed refurbishing the indoor swimming pool at Bearidise! The pool has been in continuous service since January 1993 and the old liner was showing signs of needing replacement. Here are the steps that we went through to refurbish the pool!

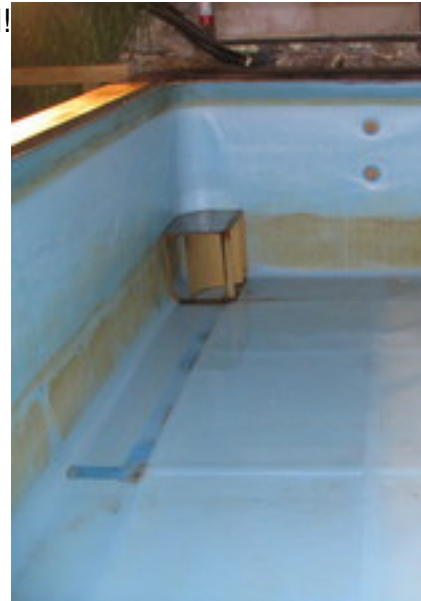
Drain pool, remove about 100 stainless steel 10-32 screws, and remove all the benches and brackets. Disconnect the hydraulic motor lines and feed through the wall fittings

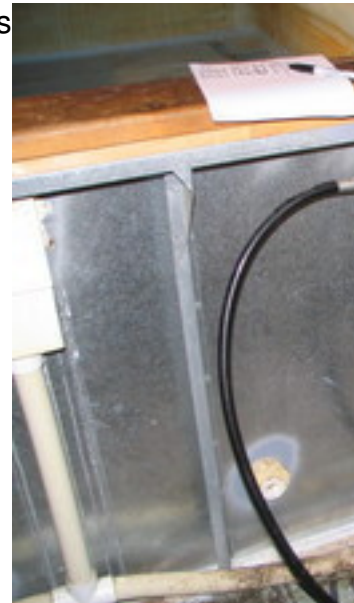
Insulation had to be removed from 7 sections of the pool to access the through-wall fittings. The 2 jet sections had about 10 pieces each

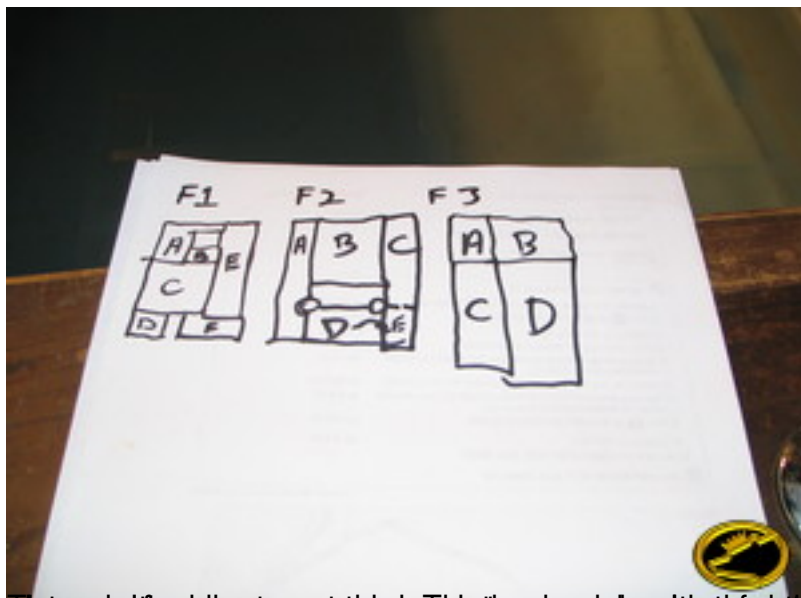
Picture of a hand-drawn diagram showing the layout of the pool sections. The diagram is divided into three main sections: F1, F2, and F3. Each section is further divided into smaller sub-sections labeled A, B, C, D, and E. The diagram is drawn on a piece of paper with a yellow circular logo in the bottom right corner.

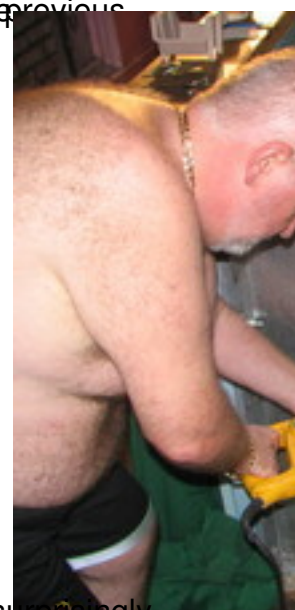
That day found multiple trips to the hardware store. The PVC tubing had to be cut. Fittings were surprisingly

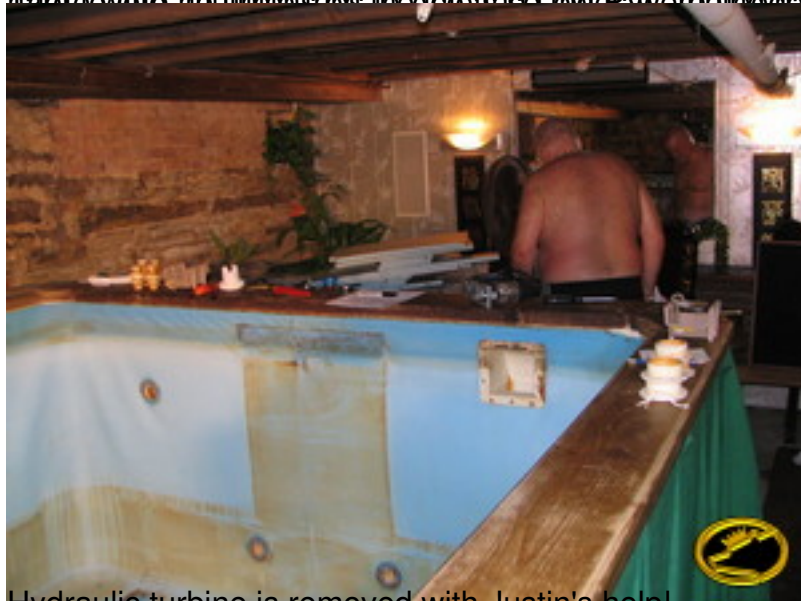
Hydraulic turbine is removed with Justin's help!

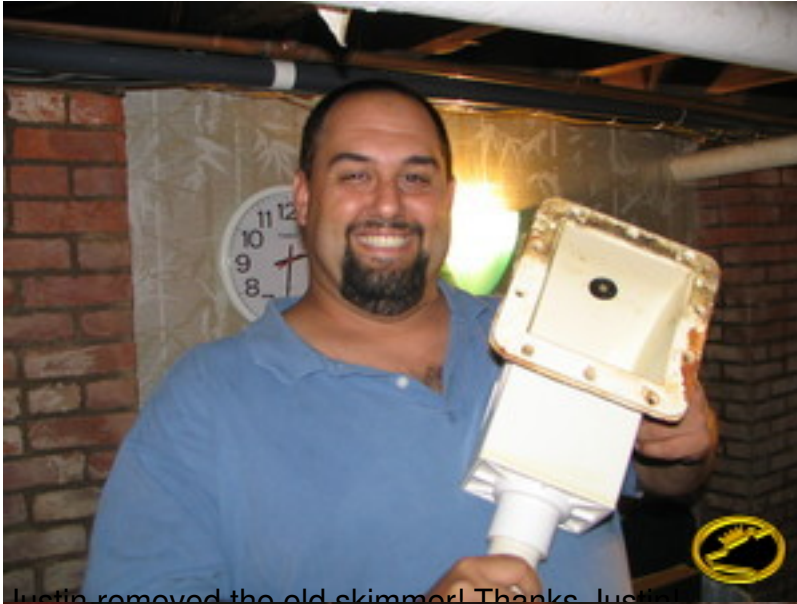
Justin removed the old skimmer! Thanks Justin!

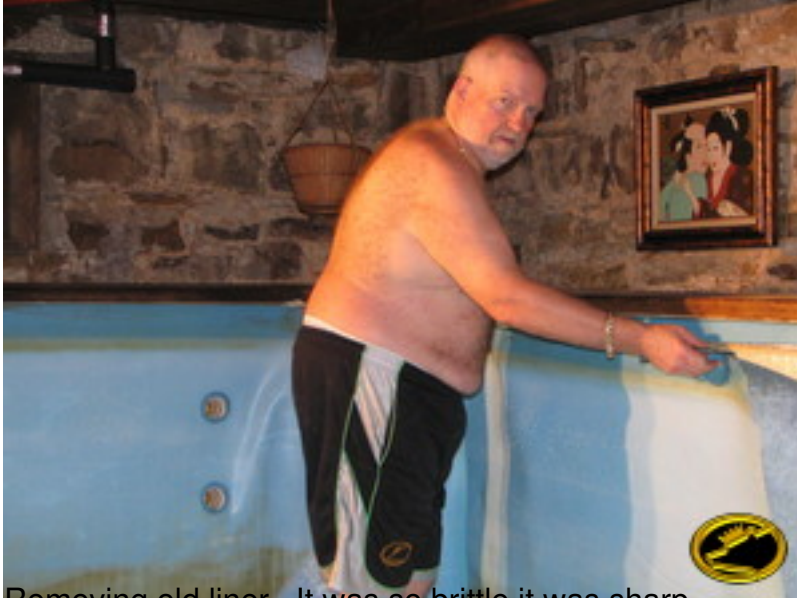
Removing old liner. It was so brittle it was sharp

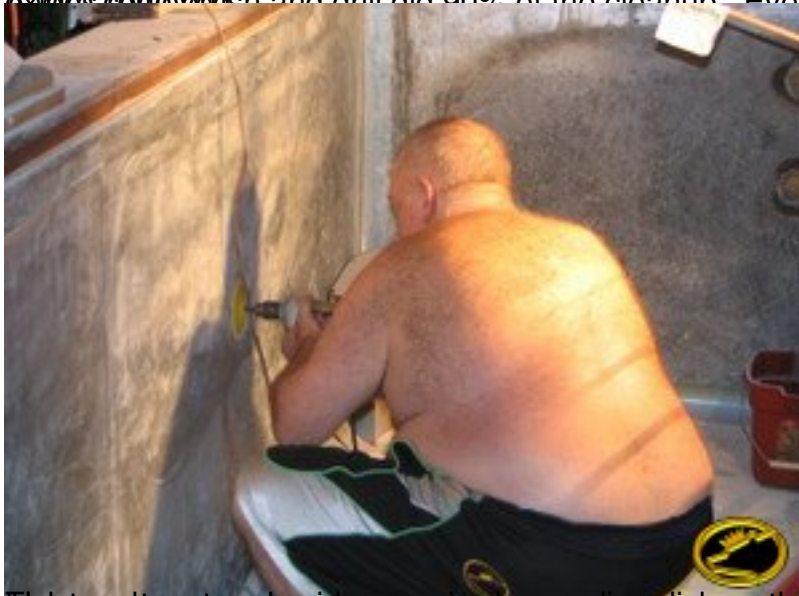
A wire scrubber and drill did 90% of the cleanup. Every part of every panel needed zinc

Flux to get the rust and oxides required a sanding disk on the drill which made quick work of some

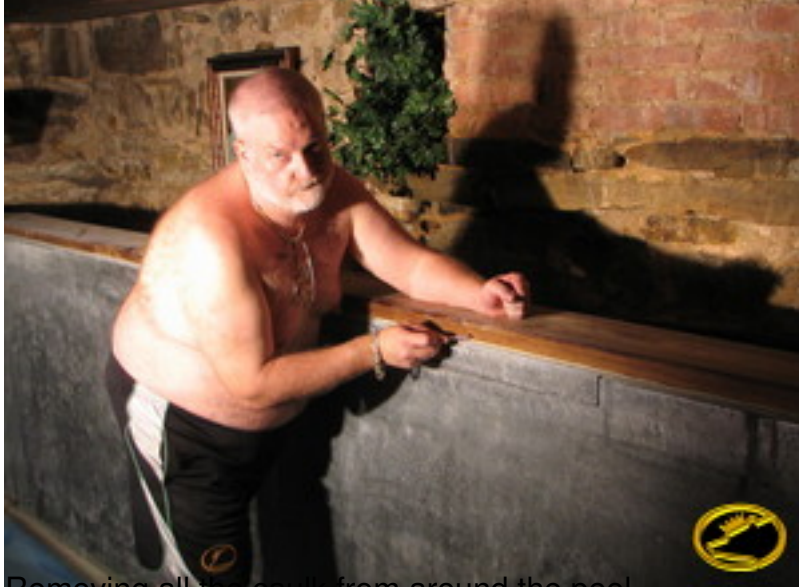
Removing all the caulk from around the pool ...

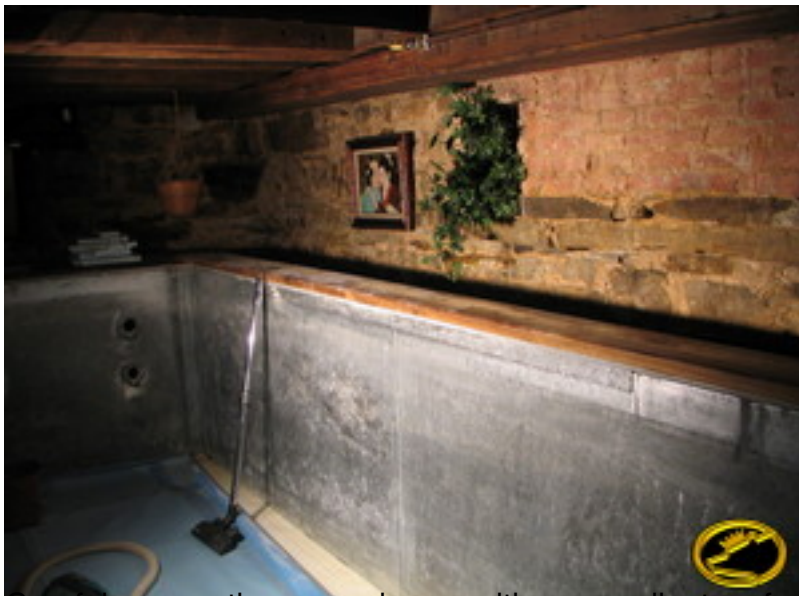
Careful preparation rewards one with an excellent surface to receive paint

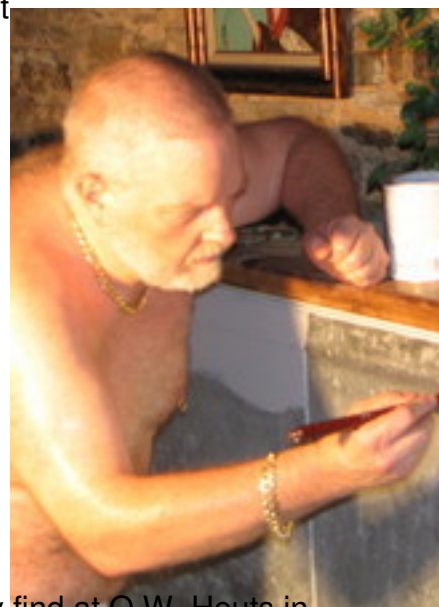
Priming the walls with a special galvanize friendly primer that I could only find at O.W. Houts in

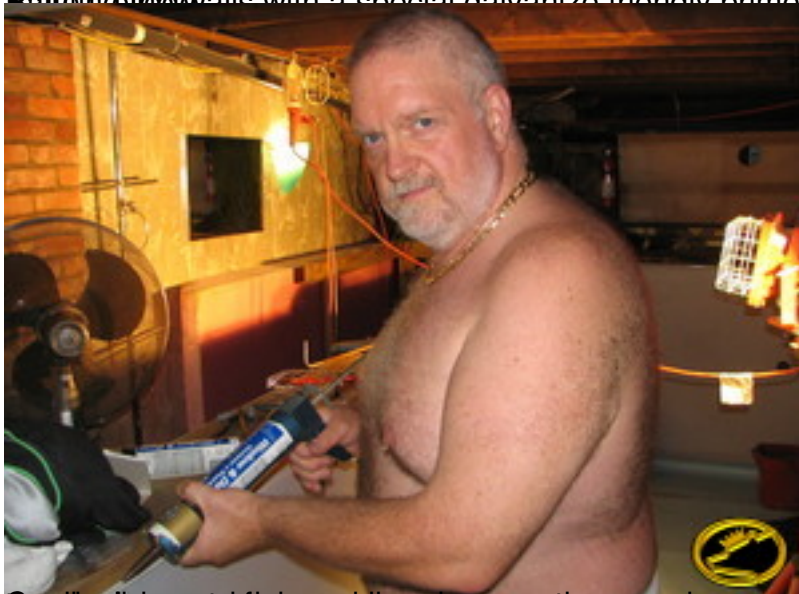
On the back of the pool liner hanger, then use brown caulk for under the coping. Just as well

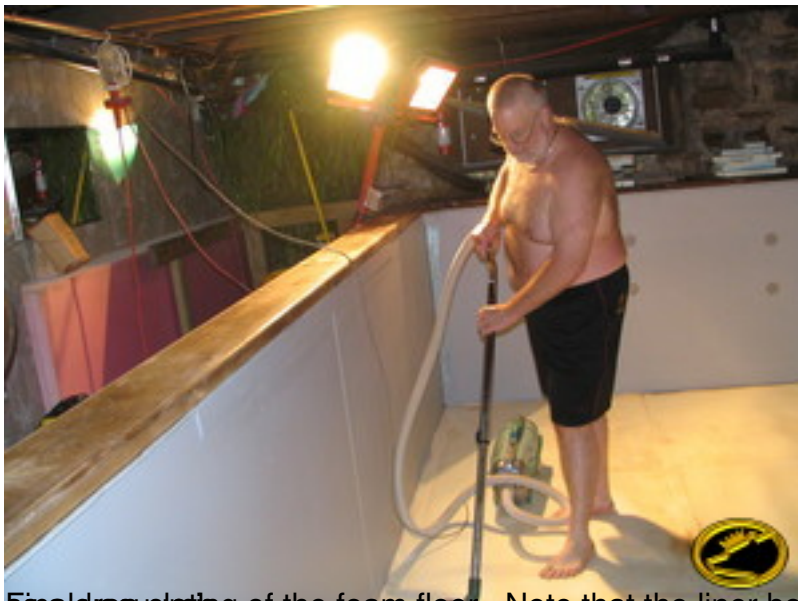
Final vacuuming of the foam floor. Note that the liner bottom has been discarded after serving

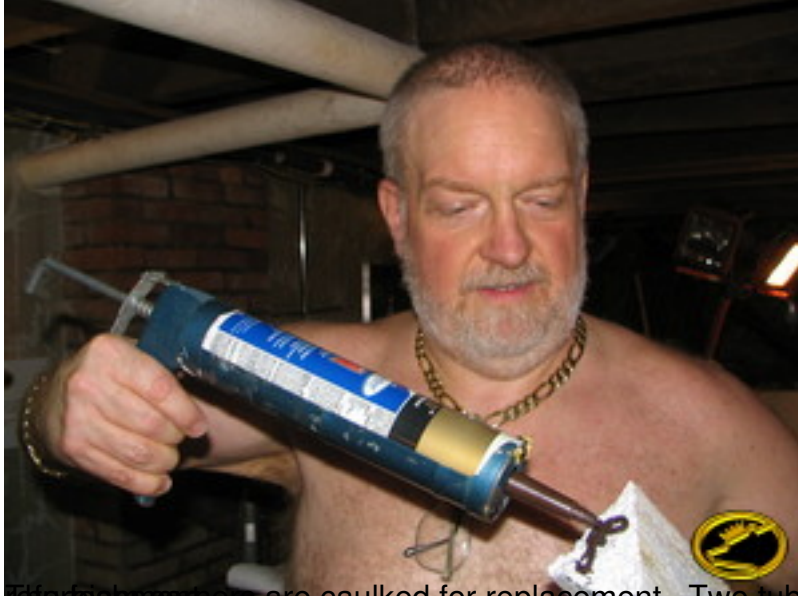
Refer to the previous photo where the joints are caulked for replacement. Two tubes of caulk were used in the

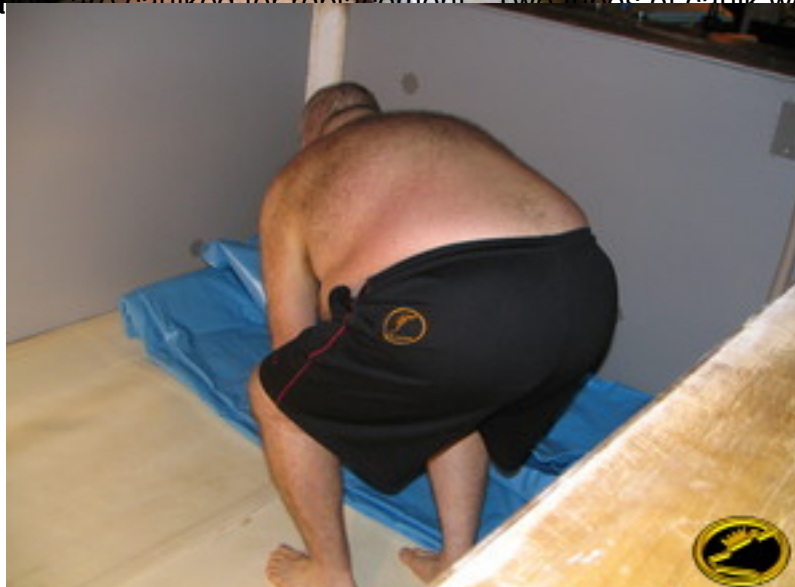
New liner positions that I put in the pool. Note that I am about to install the liner with the

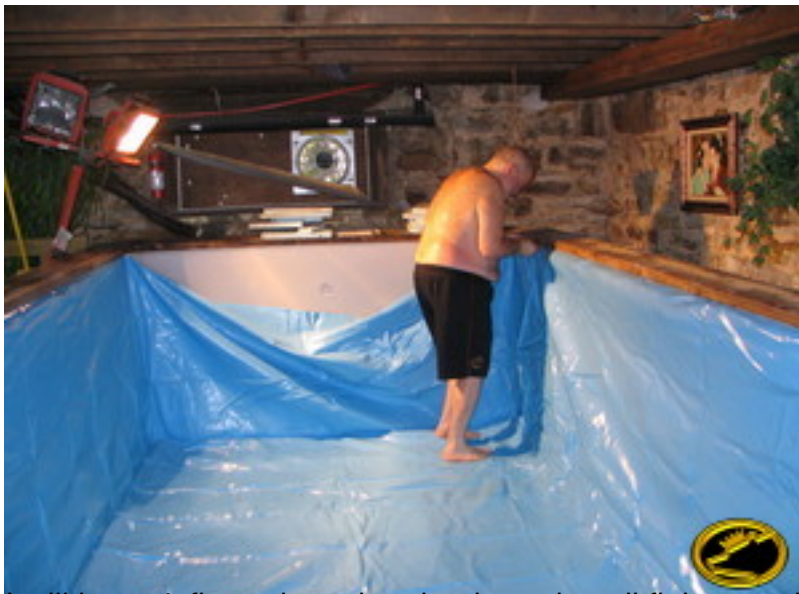
I still haven't figured out that the through-wall fittings at the other end have to be installed!

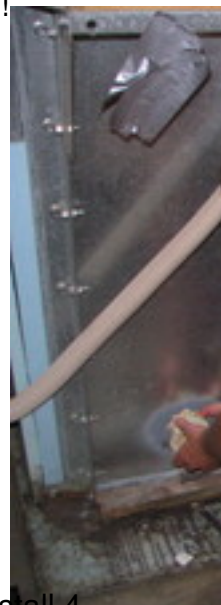
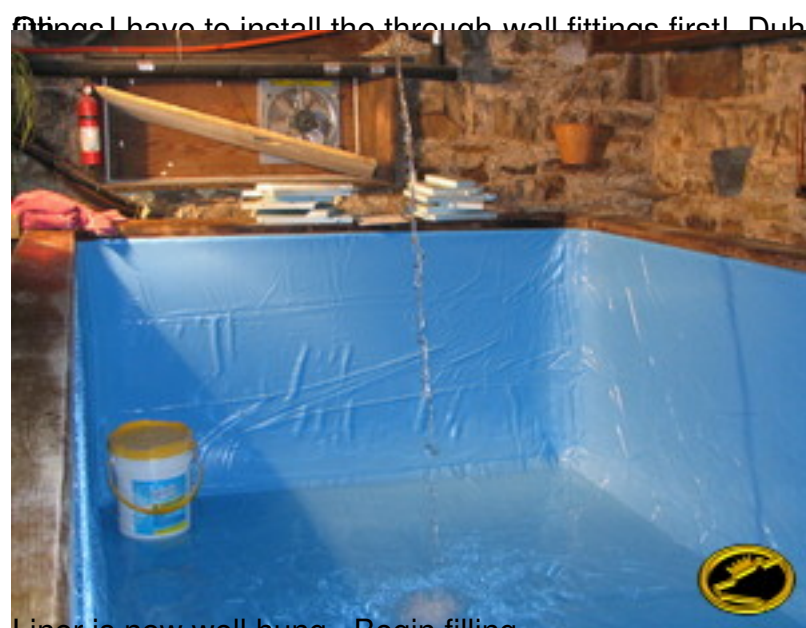
Liner is now well hung. Begin filling

Things I have to install the through wall fittings first! Duh! Unhang part of the liner and install 4

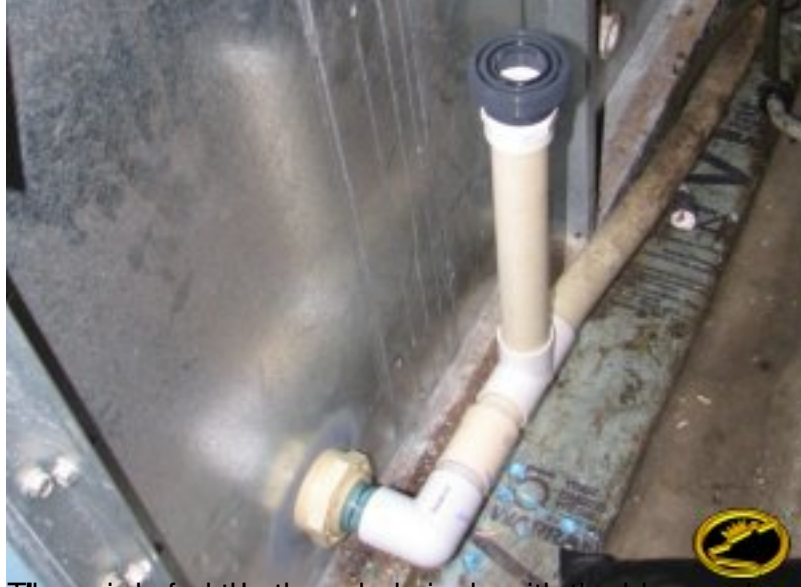
The only problem was the threaded nipple with the blue cap, as it was only available from Ace, the

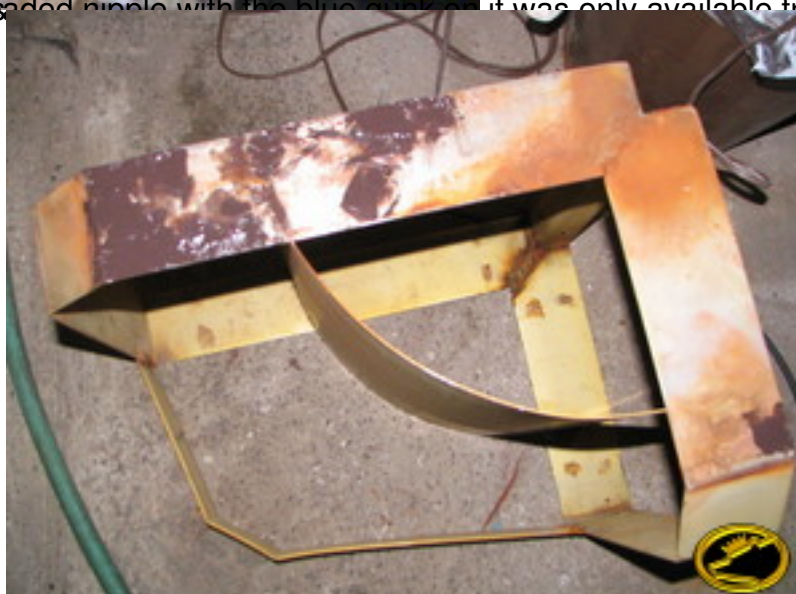
The stainless supports had corrosion problems; I ground down the corrosion and filled it in with

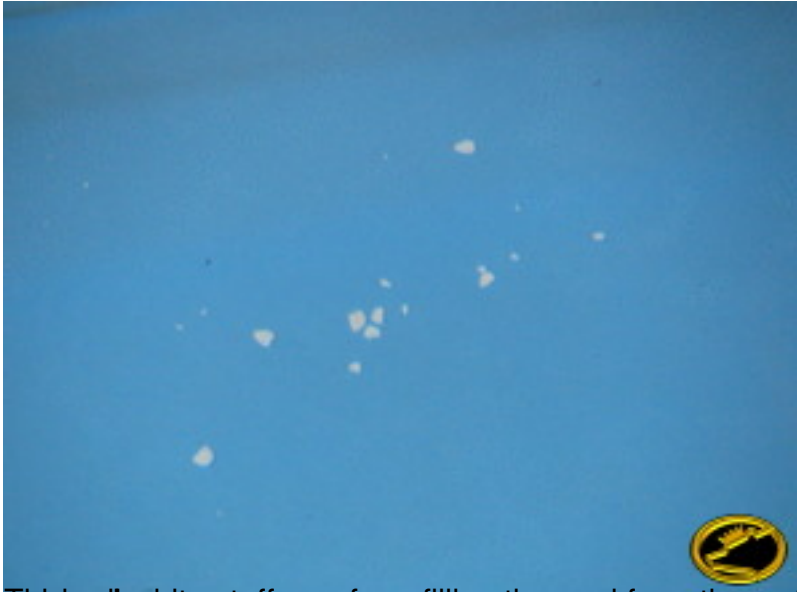
This is the white stuff that was from filling the pool from the water heater. I had to siphon it out with a garden hose.

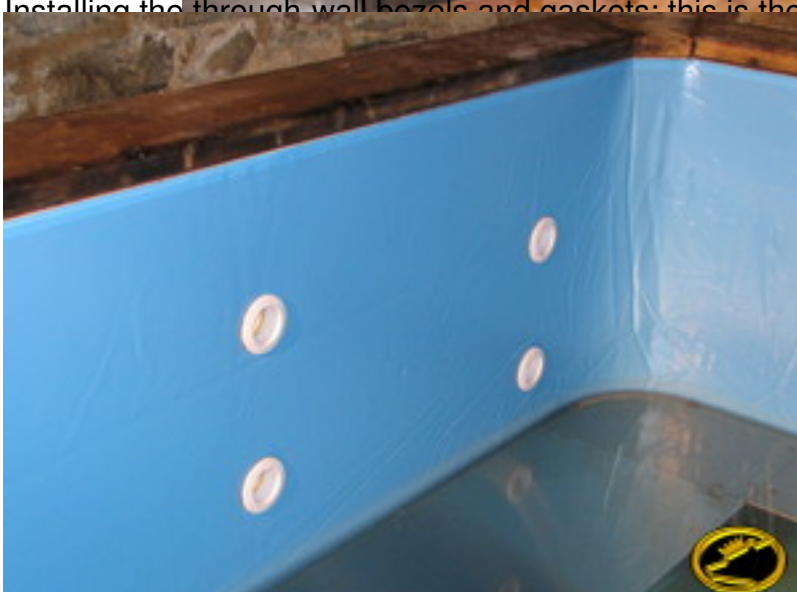
The jets were the most difficult part of the refurbishment. Thanks Jason!

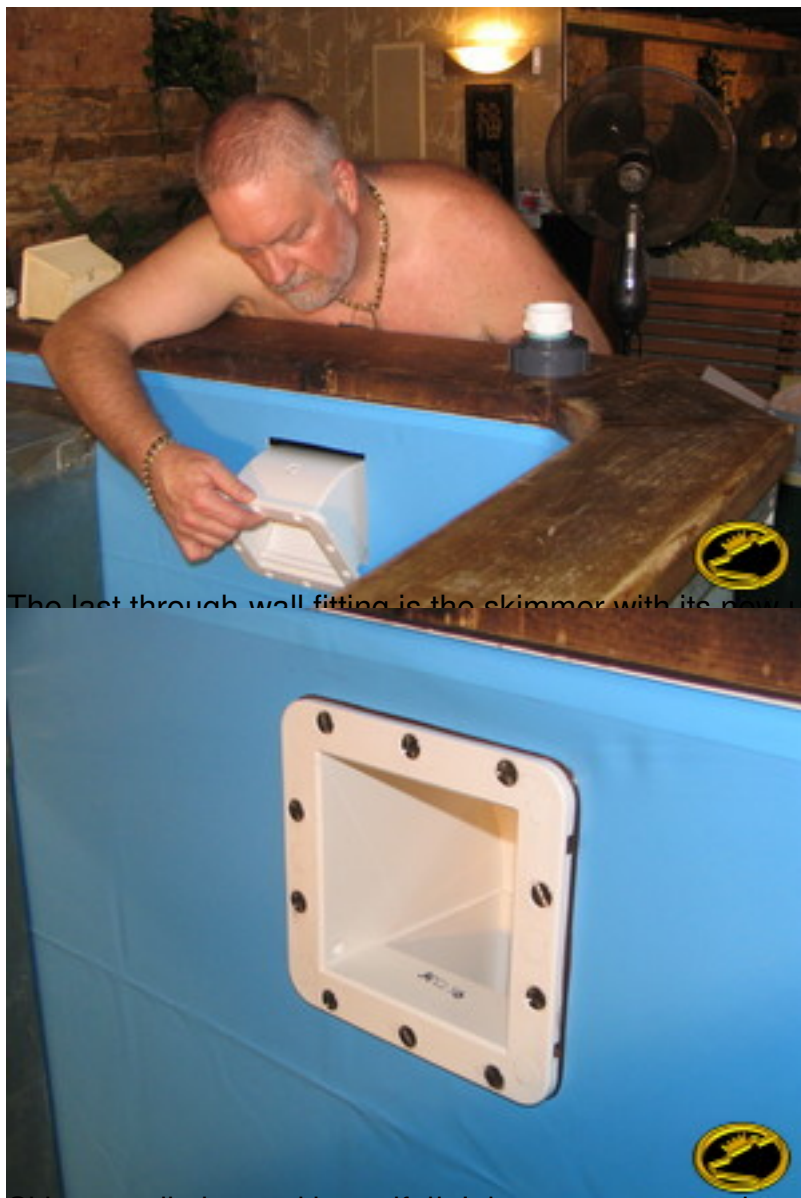
The last through wall fitting is the skimmer with its new union!

Skimmer all nice and beautiful! It has a cover over the screws now
